2018 Strategic Facilities Study

October 26, 2018

MSA Project No. 00212103

PREPARED BY:
MSA Professional Services, Inc.
1230 South Boulevard
Baraboo, Wisconsin 53913
Phone: (800) 362-4505

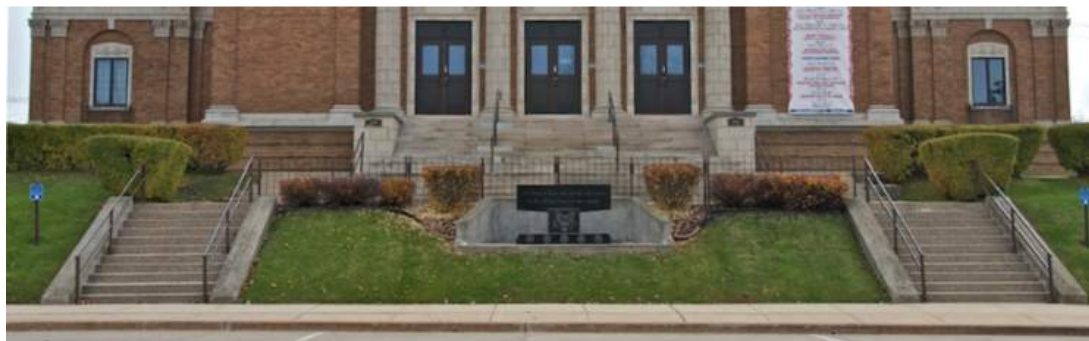
8. The north monumental stairs have lower sections that are concrete on grade, and an upper center section that is a stone covered concrete structure, which forms a ground floor room below. There are additional east and west facing exits stairs that are concrete slab on grade stairs. The stair systems connect the street to the second level with a ceremonial auditorium level entrance.

- a. There is various cracking and failure of these areas.
 - b. Sealant at the joints throughout requires replacement.
 - c. There is ongoing water infiltration in the basement area under the central stair, and has been occurring for some time. The angled concrete ceiling below the stair has exposed and rusting steel reinforcement.

- d. The railings need painting.
 - e. The central monument slab has erosion at the north outward edge that may compromise its support.
 - f. This area requires maintenance work and at least partial replacement.

- g. There are associated safety concerns at the stair and connector walk configurations that could be addressed at the time of improvements.
9. Most of the auditorium seating has deteriorated upholstery.
